RAILROAD AVENUE PHOTO LOG

**RIO TINTO
LEGACY MANAGEMENT**

SUTHERLANDS PHOTO LOG

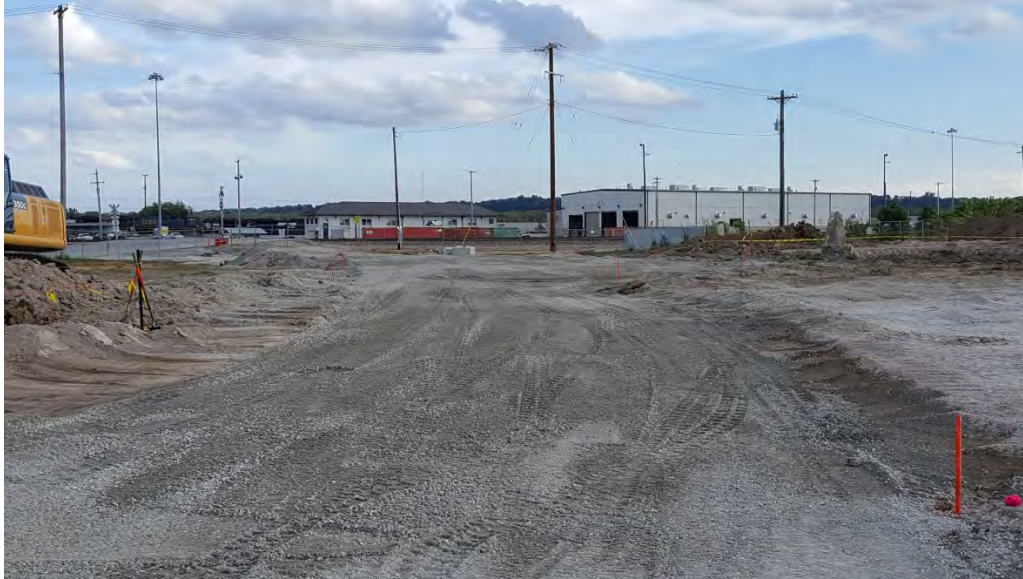
Laying base for temporary road

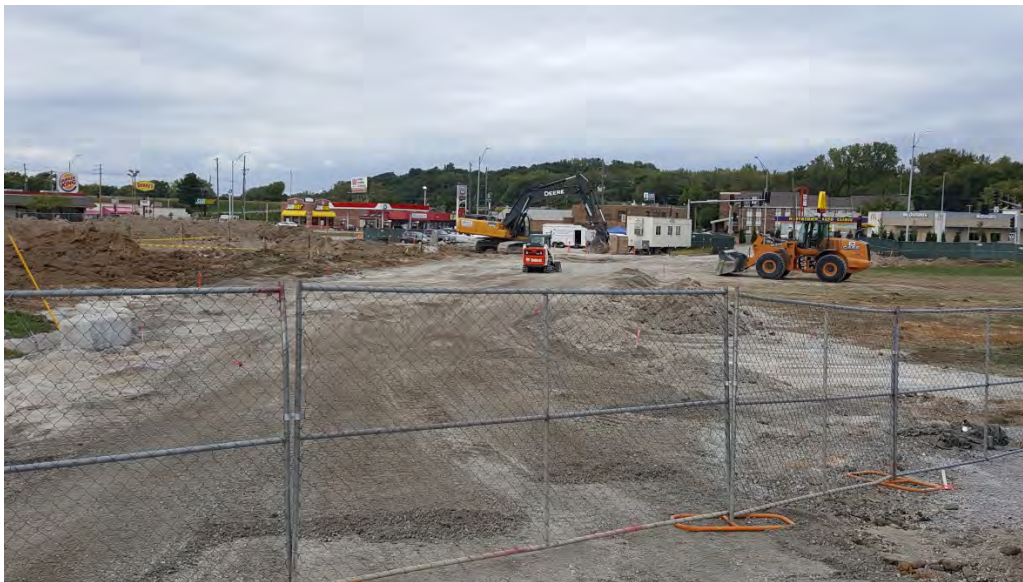
Laying base for temporary road, note security fencing

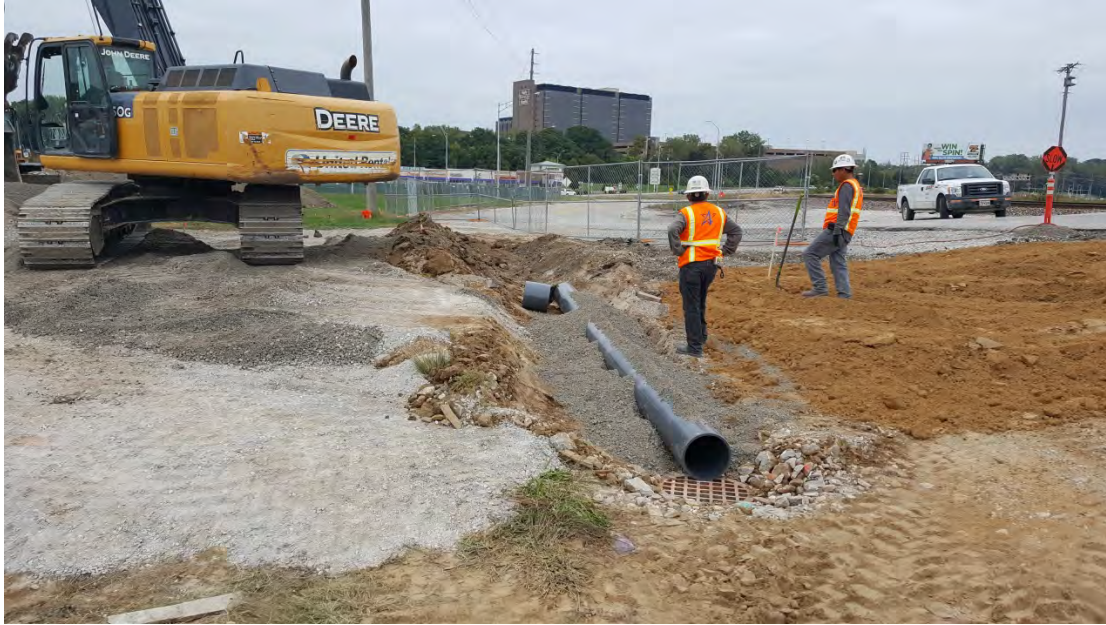
Laying drainage under low spot of temporary road

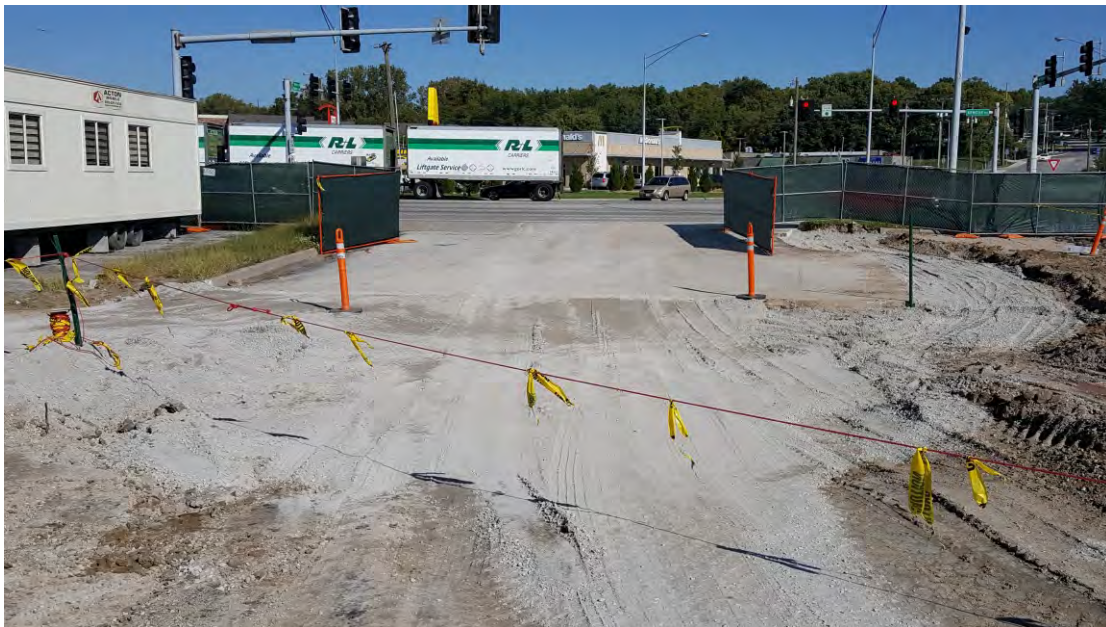
Temporary road entrance from Armour Road.

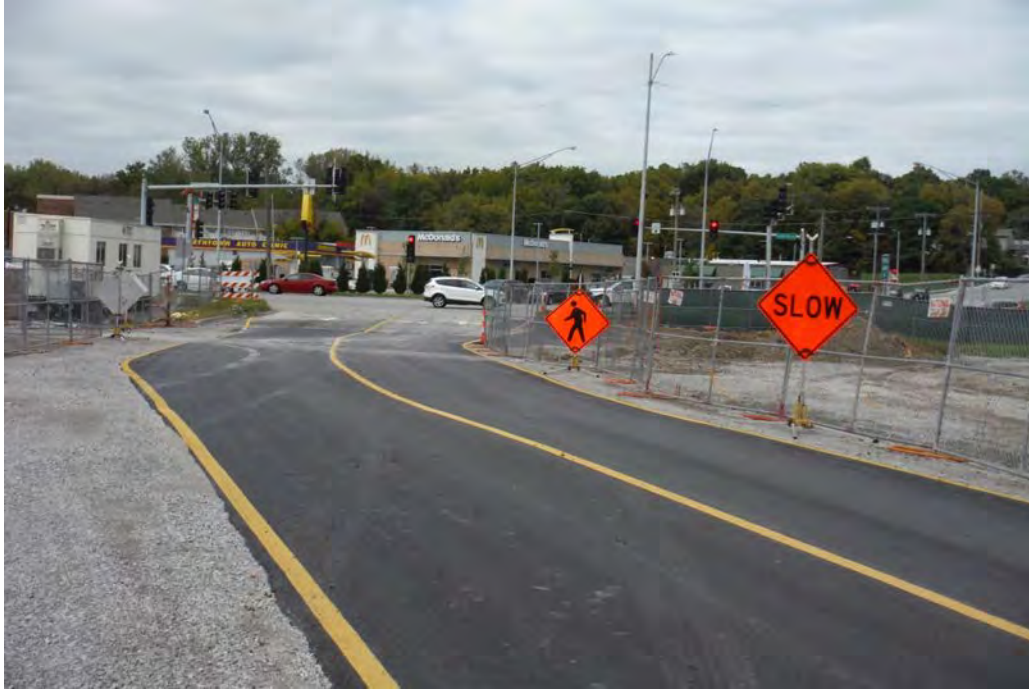
Paved segment of the temporary road

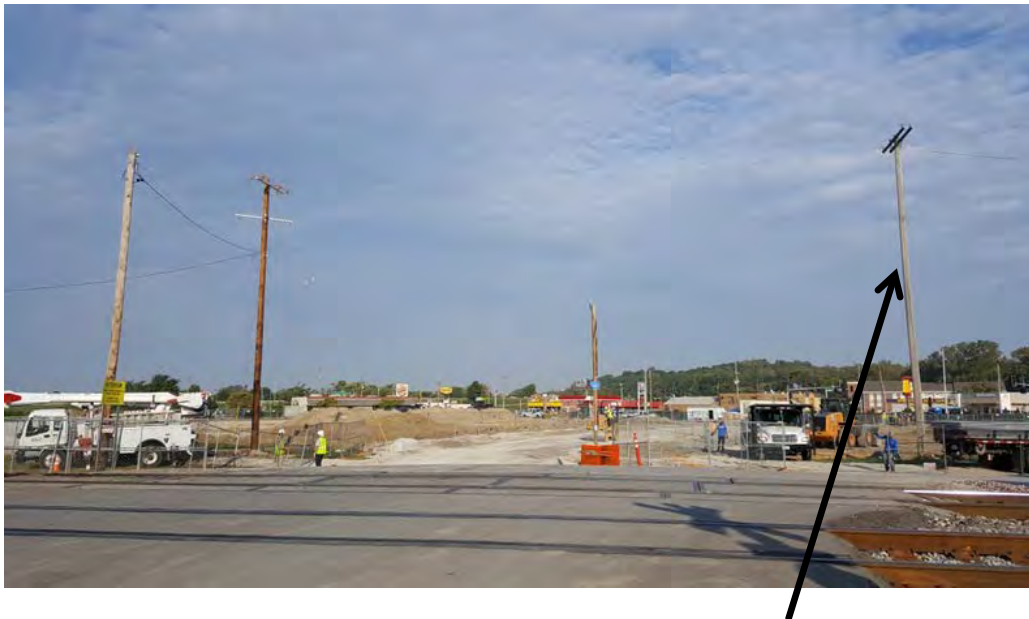
Relocating power poles. Pole eventually removed.

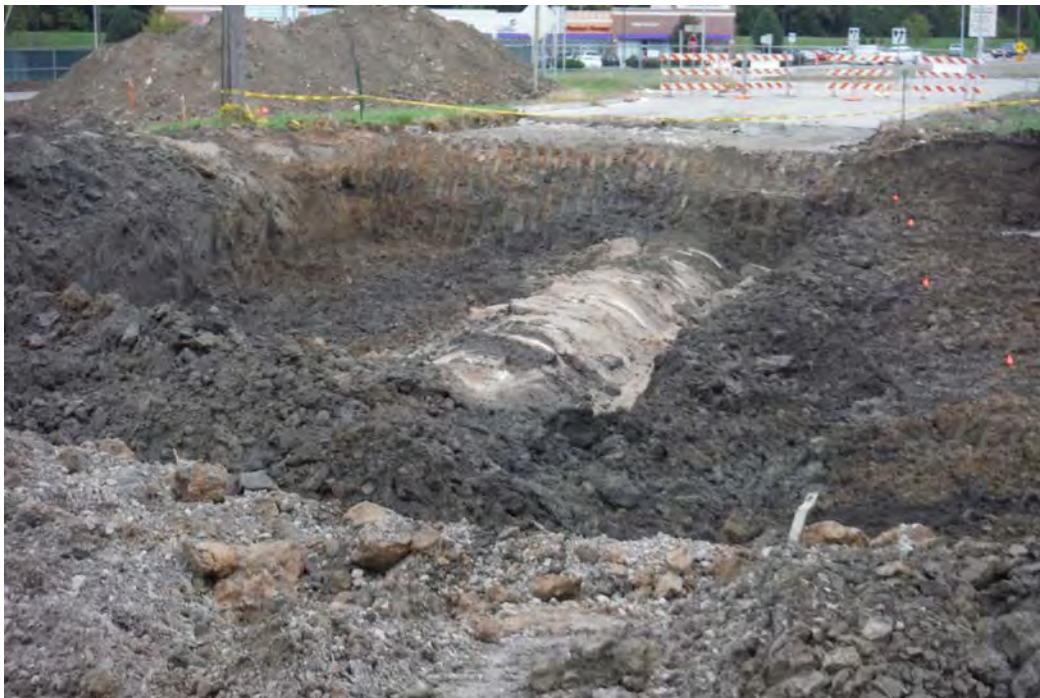
72" RCP storm sewer crown exposed

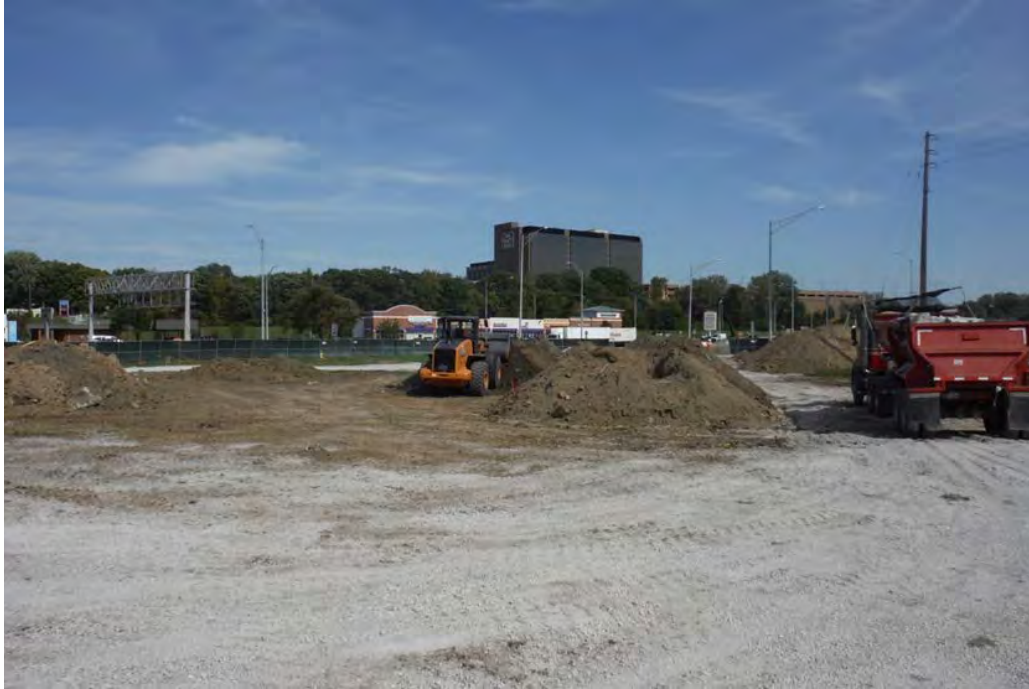
RR Avenue excavated soil staging area looking east

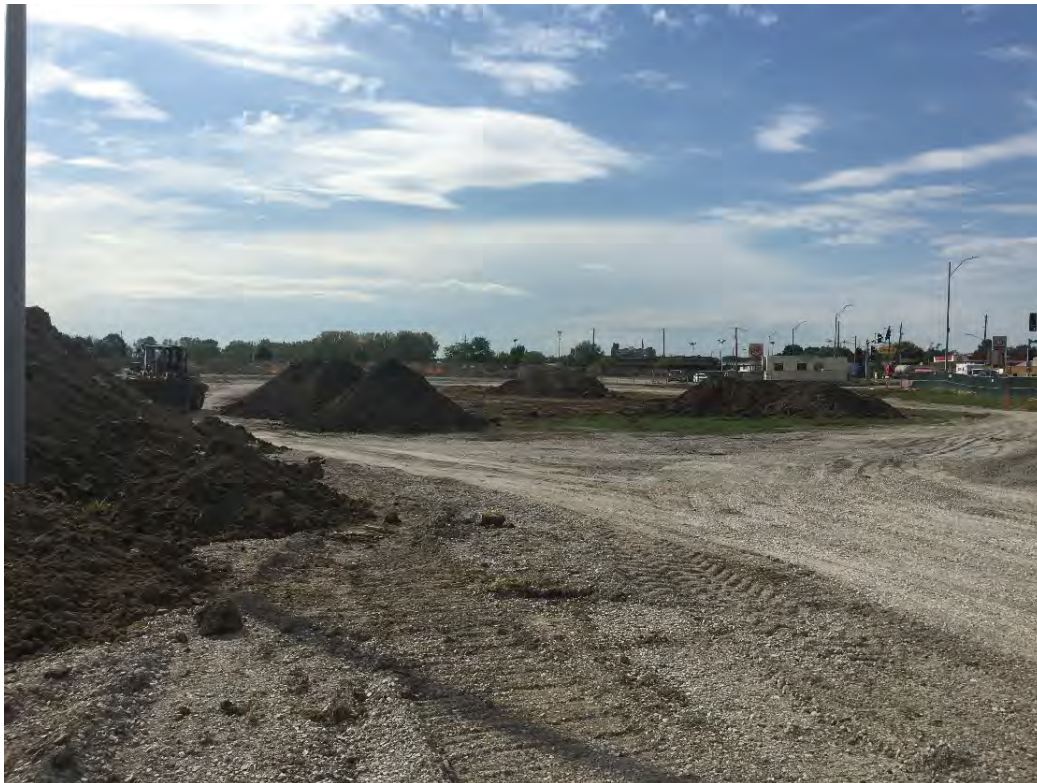
RR Avenue excavated soil staging area looking west

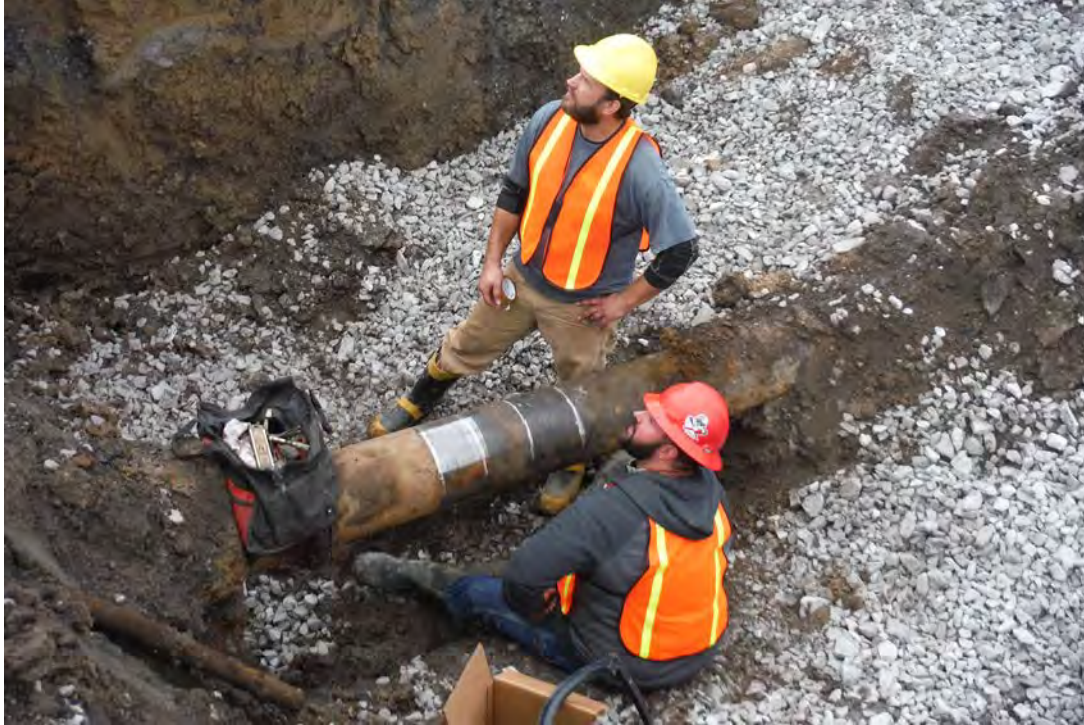
Preparation of hot tap of Municipal water line

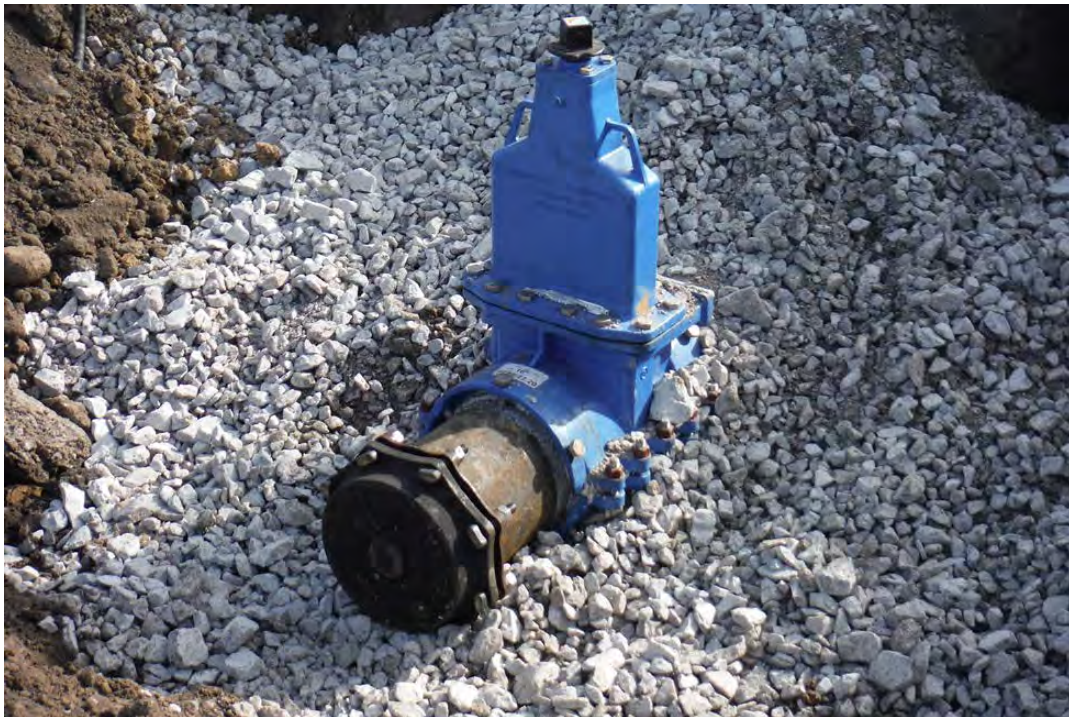
New Municipal water valve. RR Ave pipe segment isolated and removed

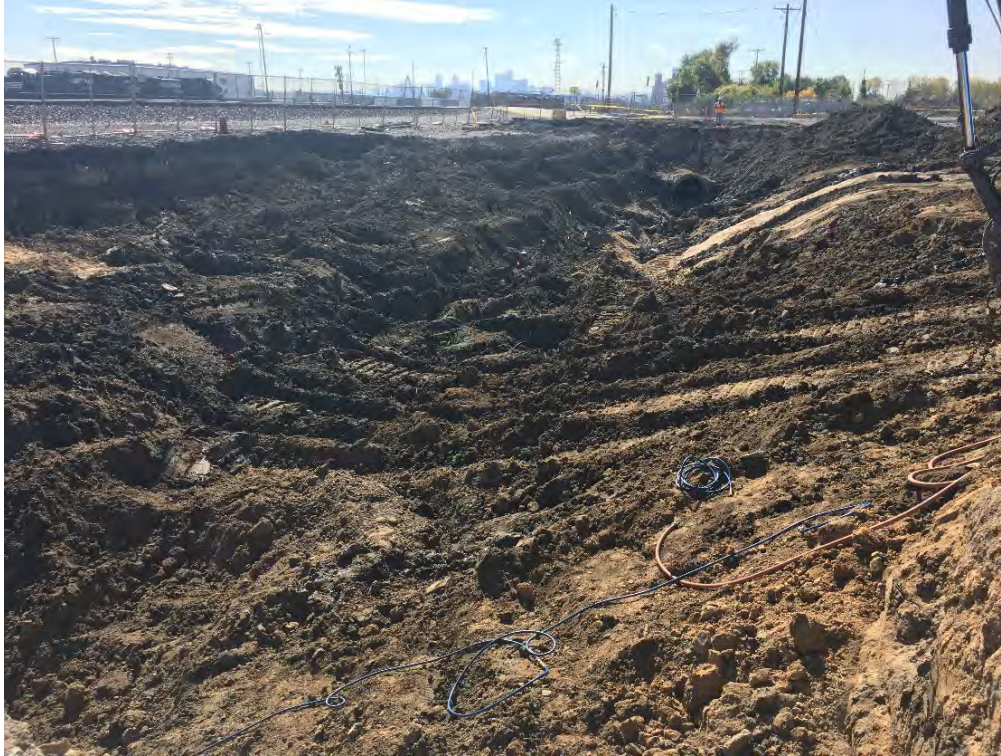
RR Ave excavated with 72" storm water pipe removed

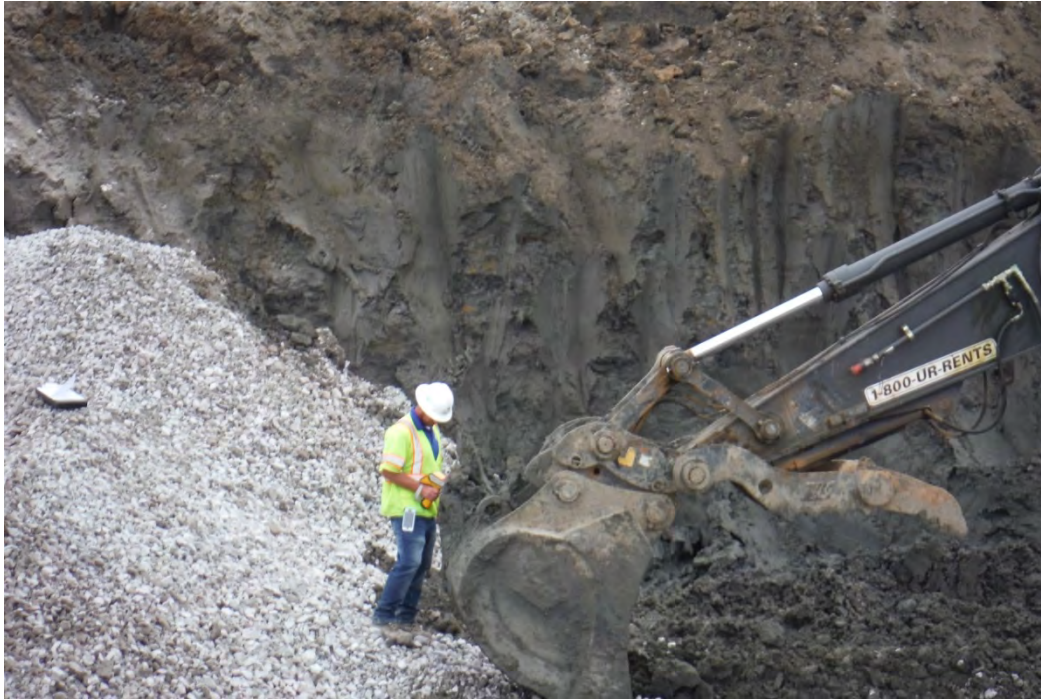
Sidewall sample collected off the vertical face with the excavator bucket.

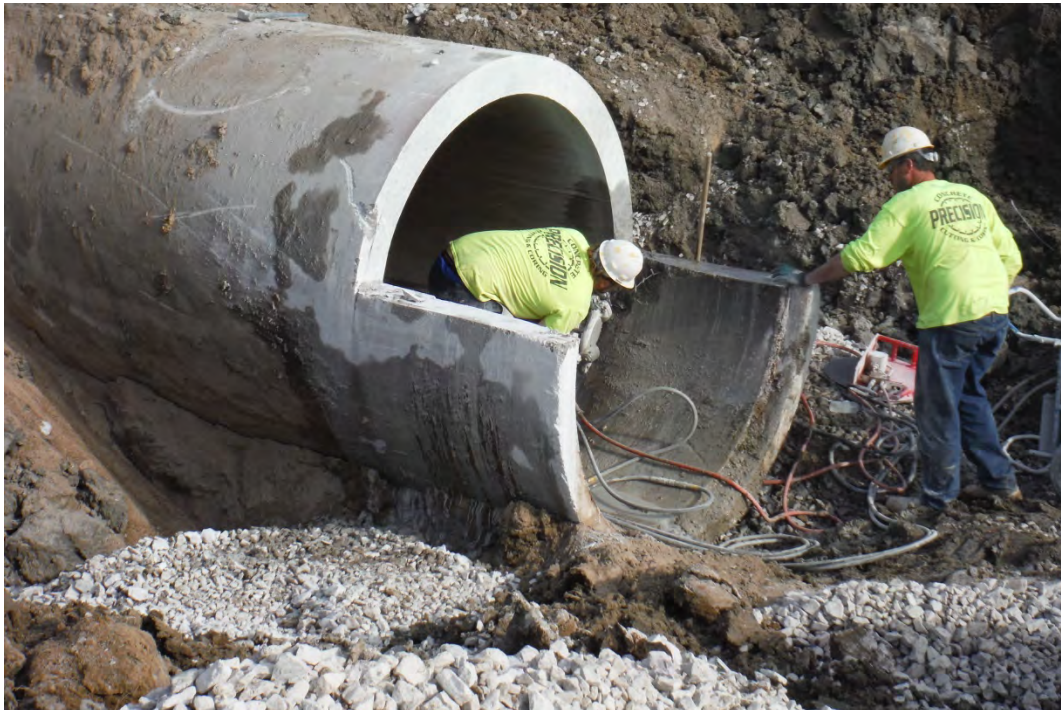
72" RCP being cut to fit the new connector box placed at this location

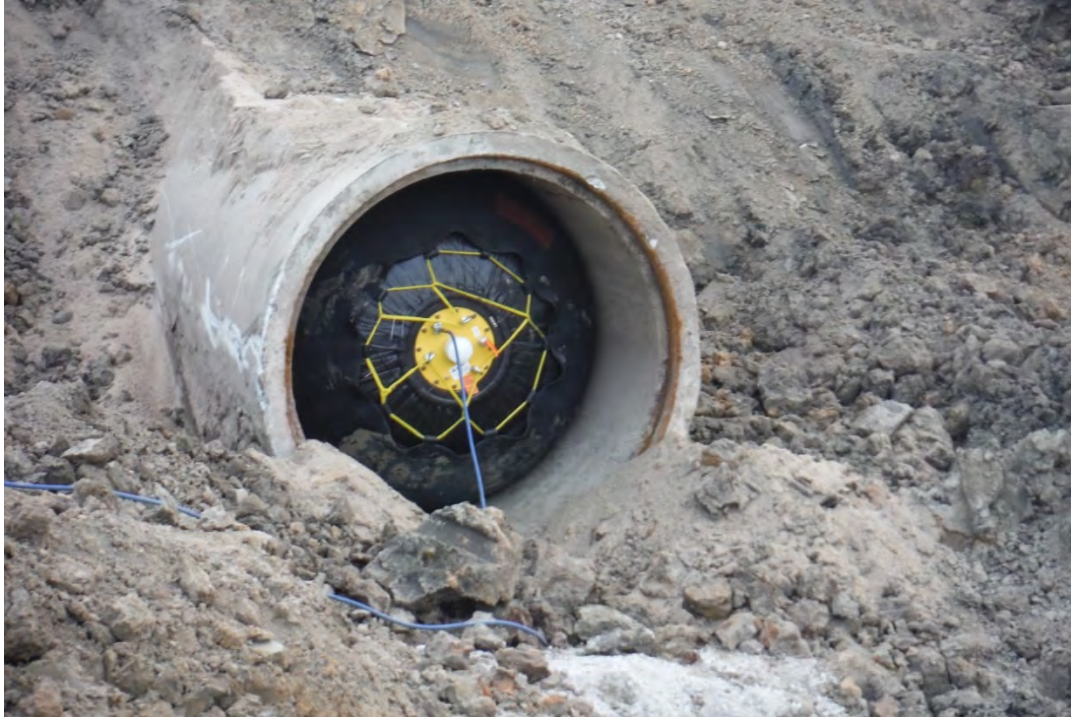
RCP plug to prevent water flow into the excavation

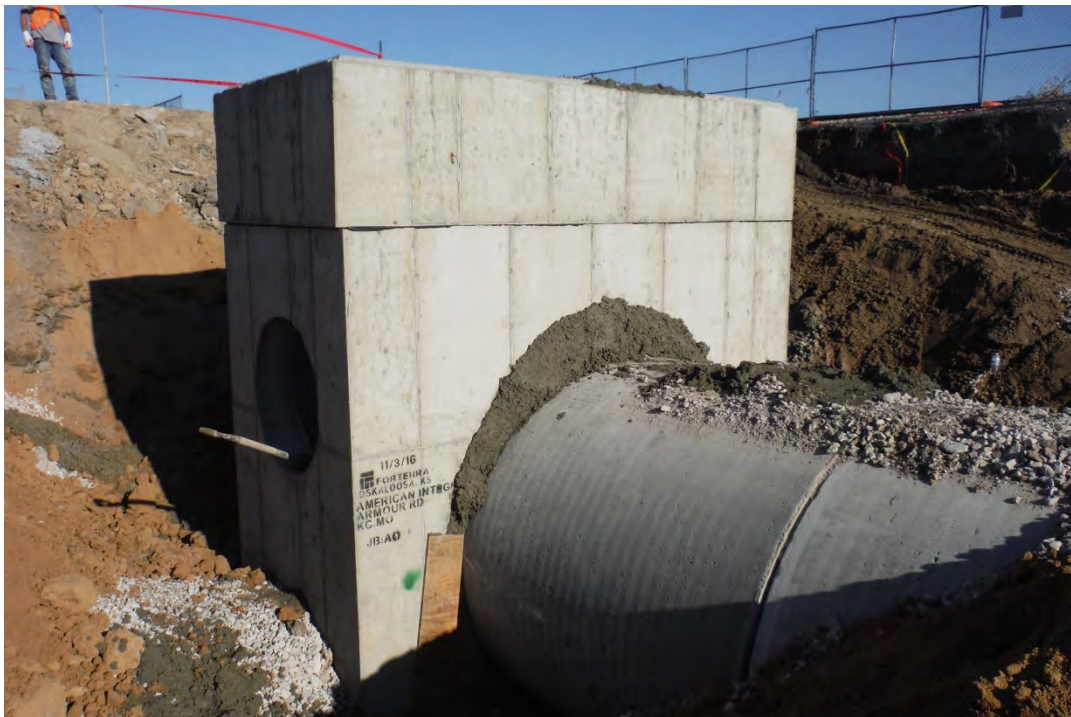
Connector box and new 72" RCP storm water pipe

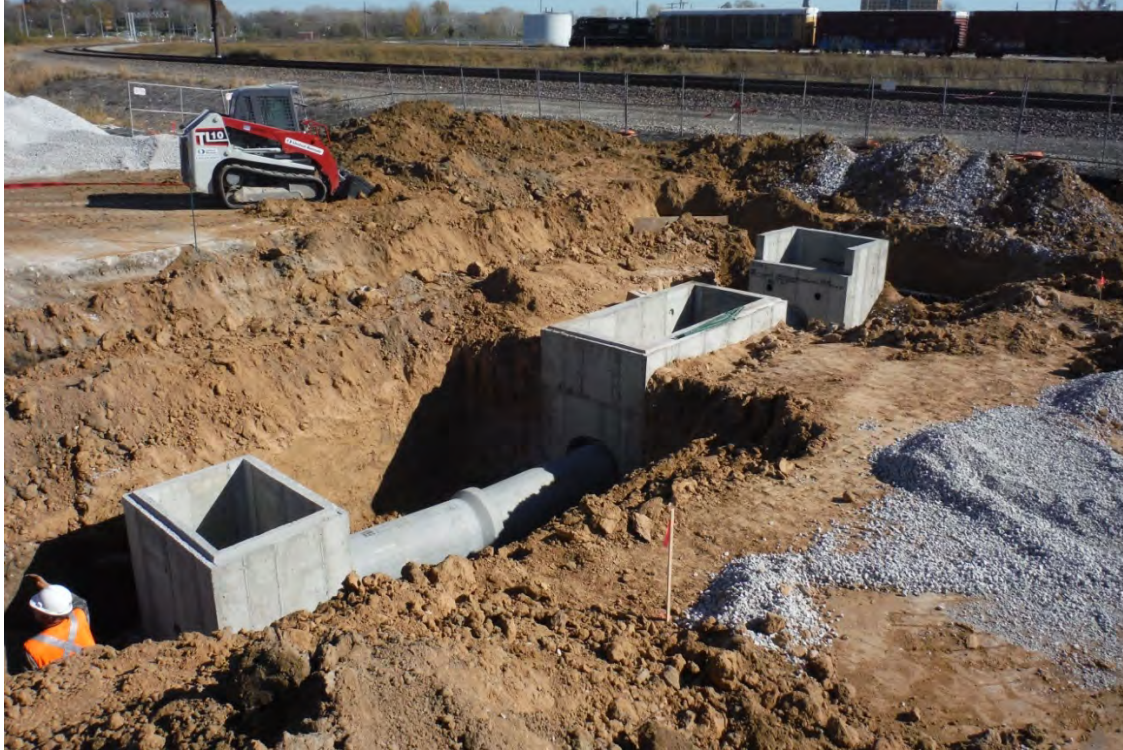
Storm water drop inlets installed for the new Railroad Ave

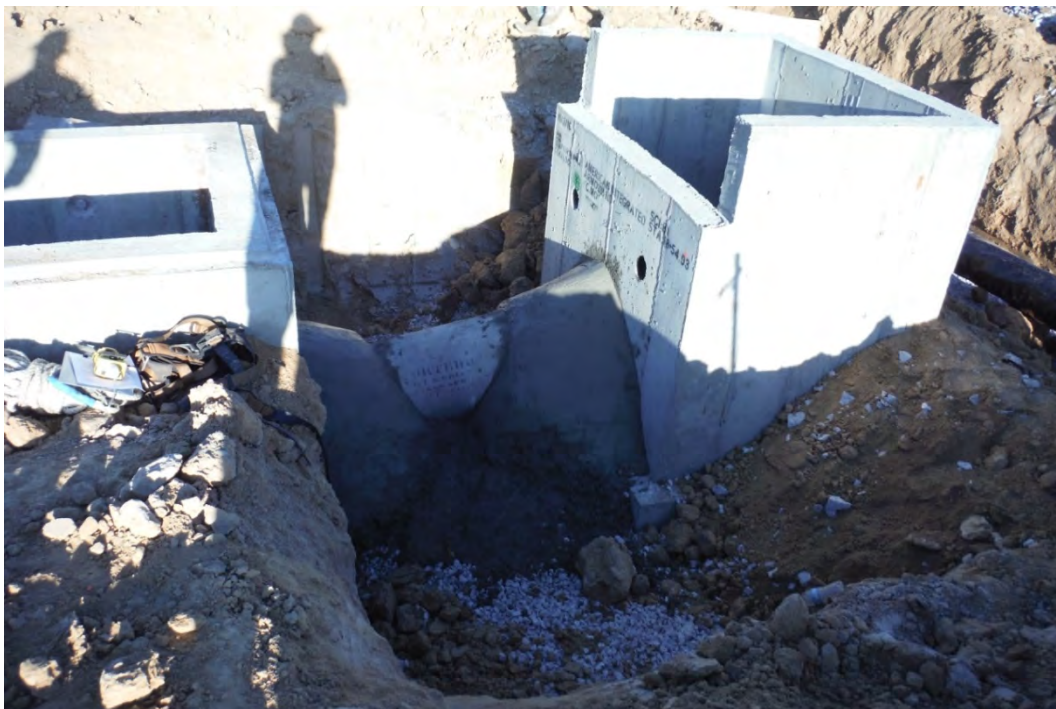
Storm water laterals sealed

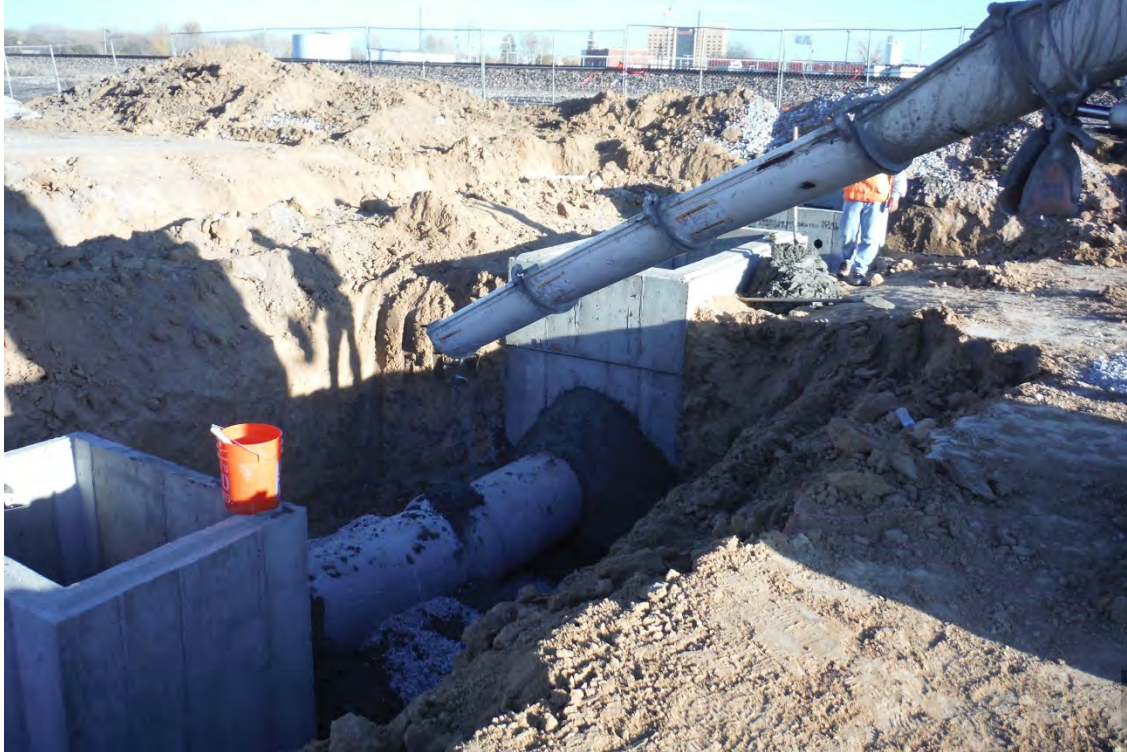
Lateral joint with deflection begin sealed

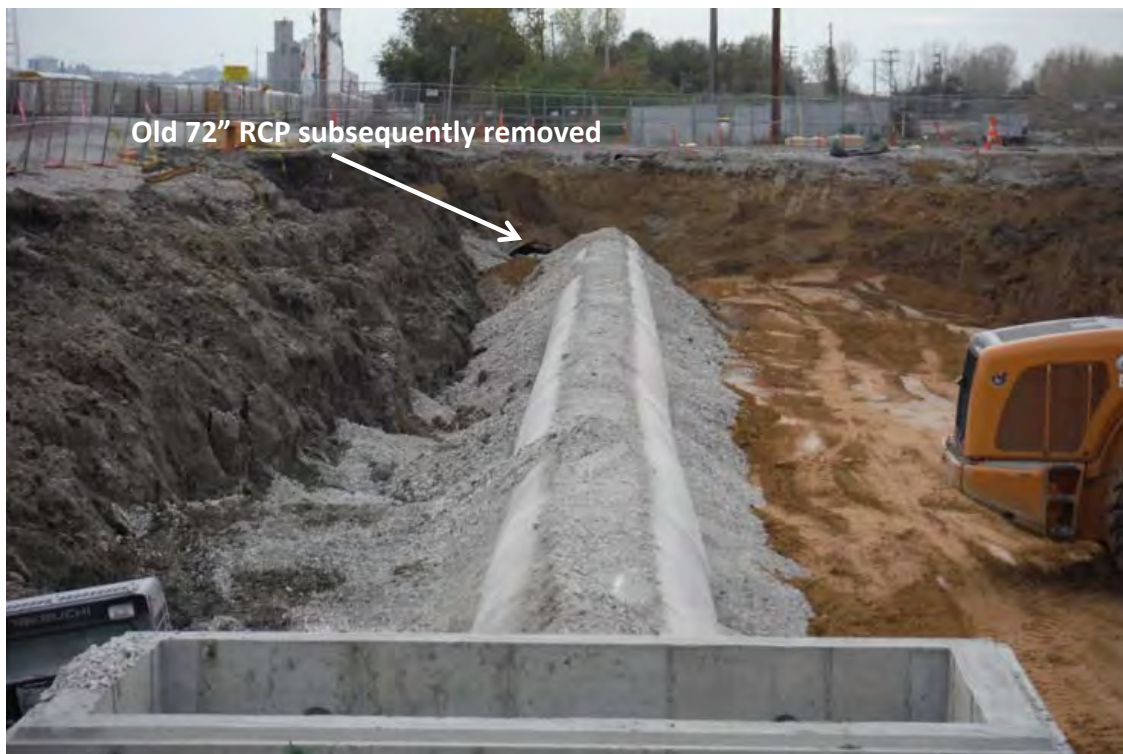
Old 72" RCP subsequently removed

New 72" RCP alignment.

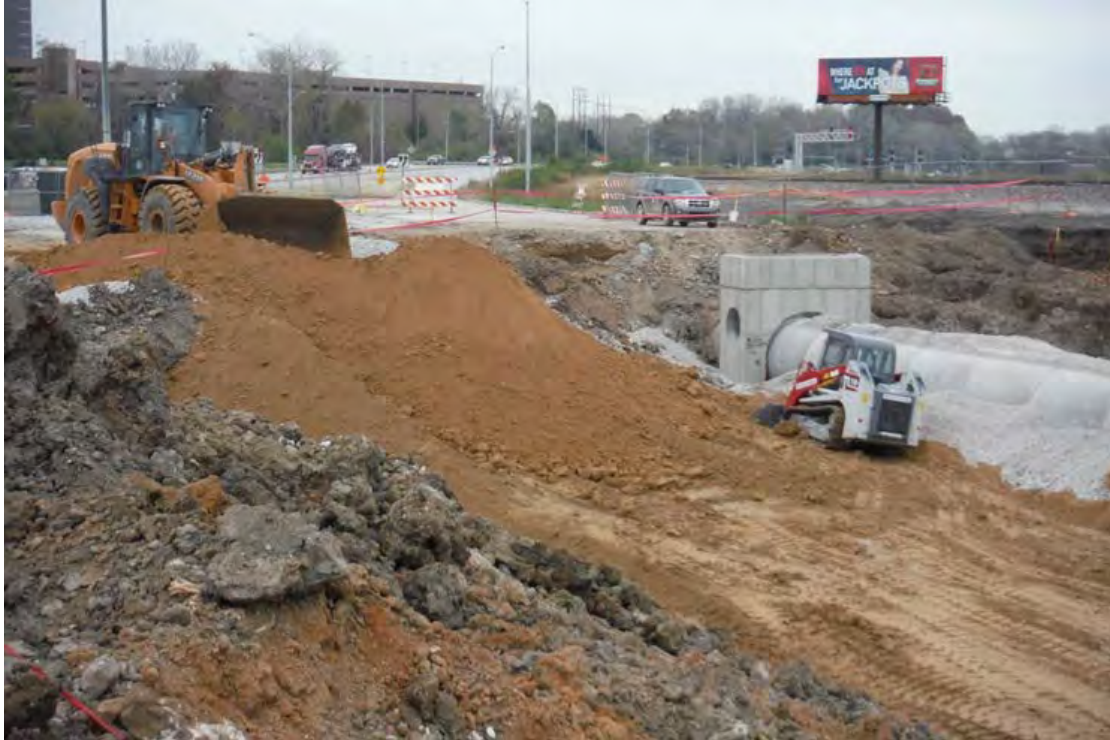
Backfill started

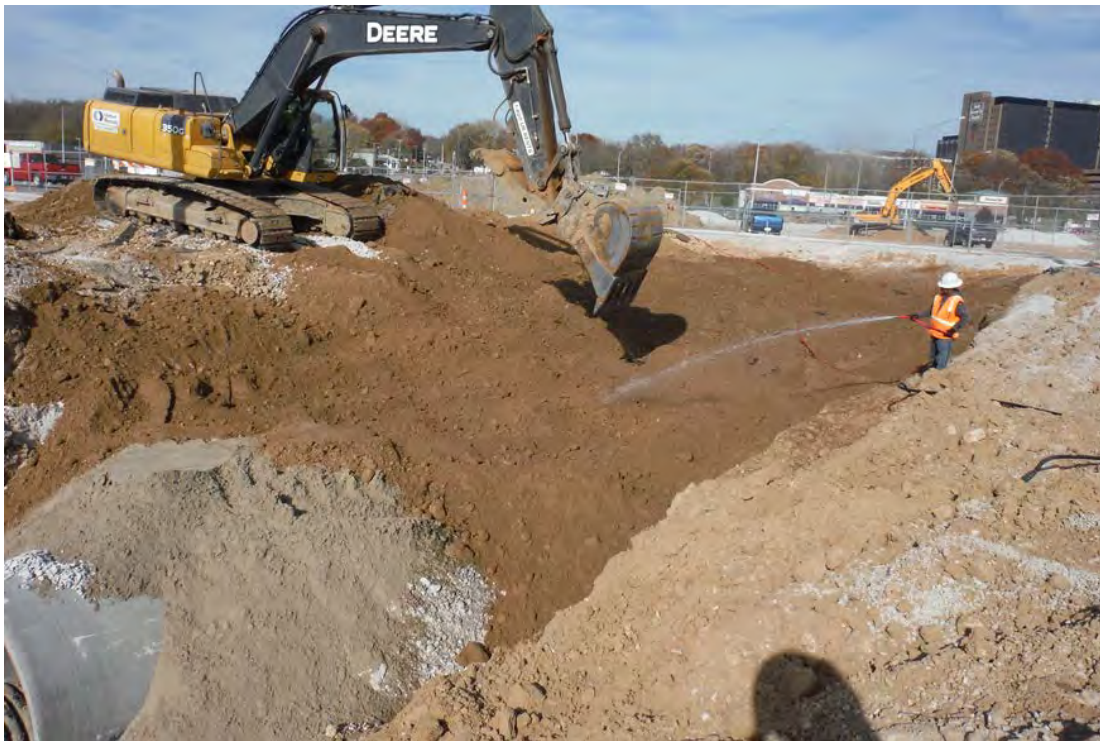
Backfill continues, watering to achieve compaction

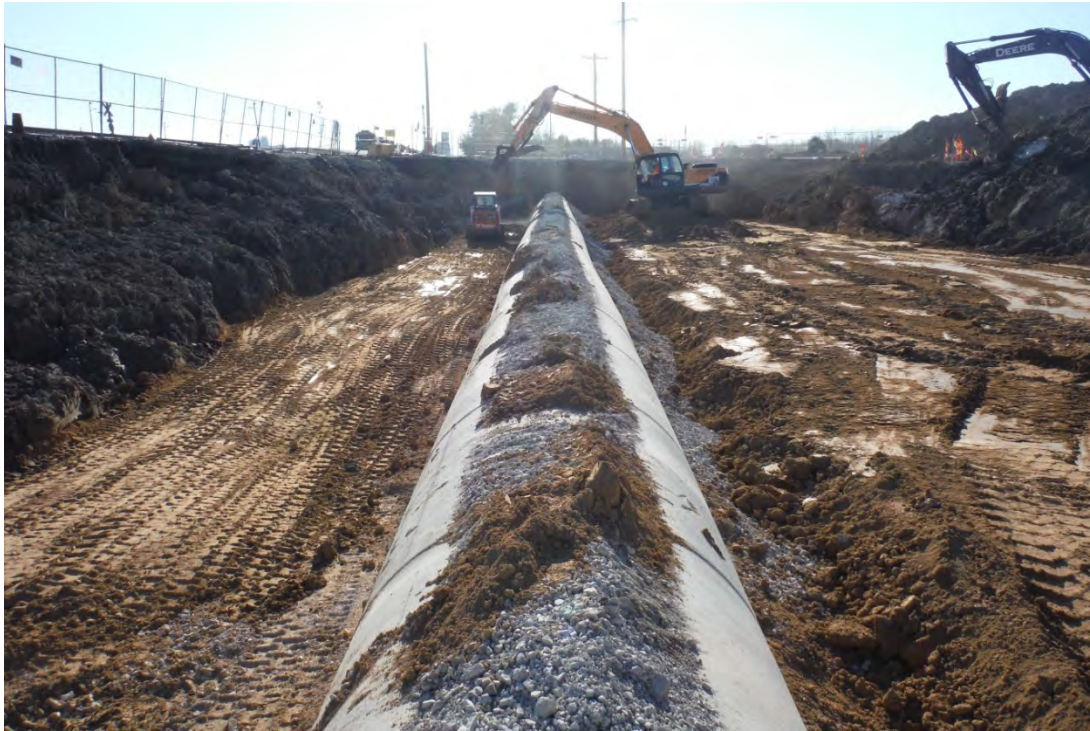
Backfill half completed

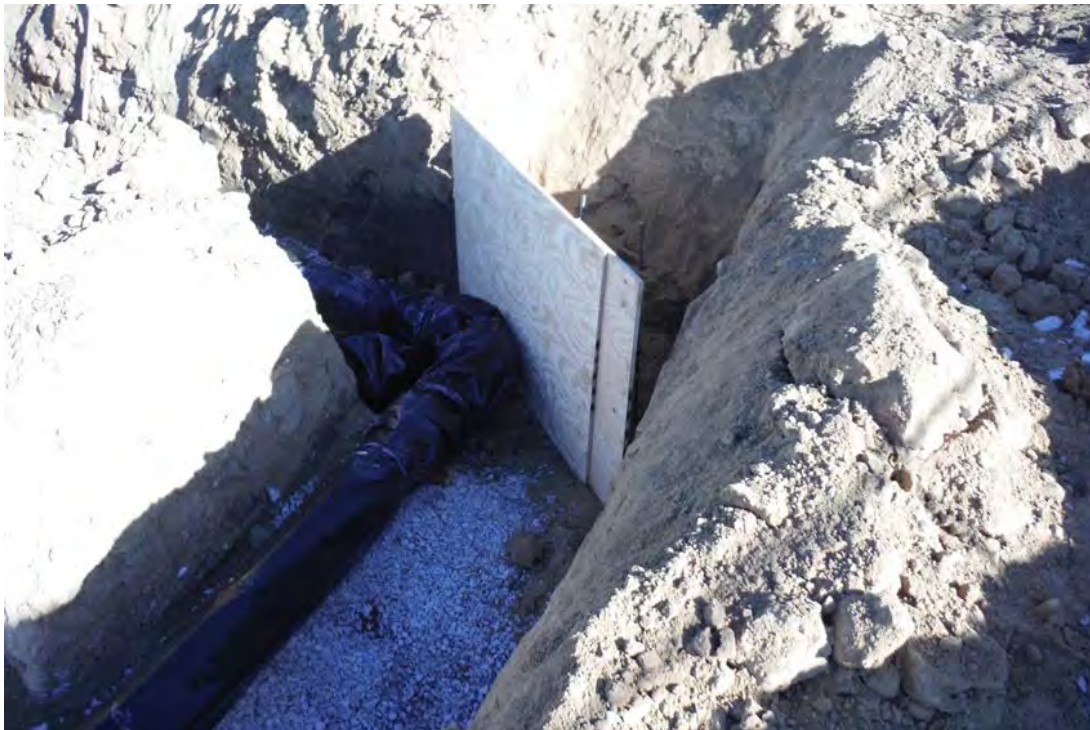
Thrust block form for new Municipal water pipe

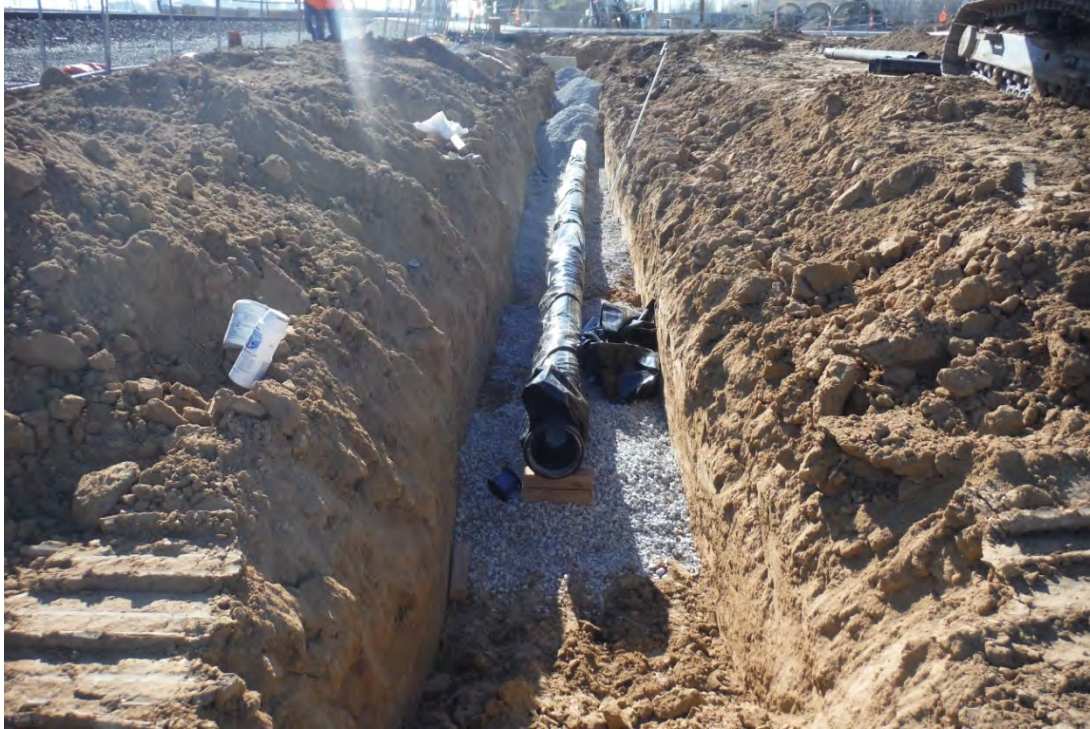
Municipal water pipe being placed

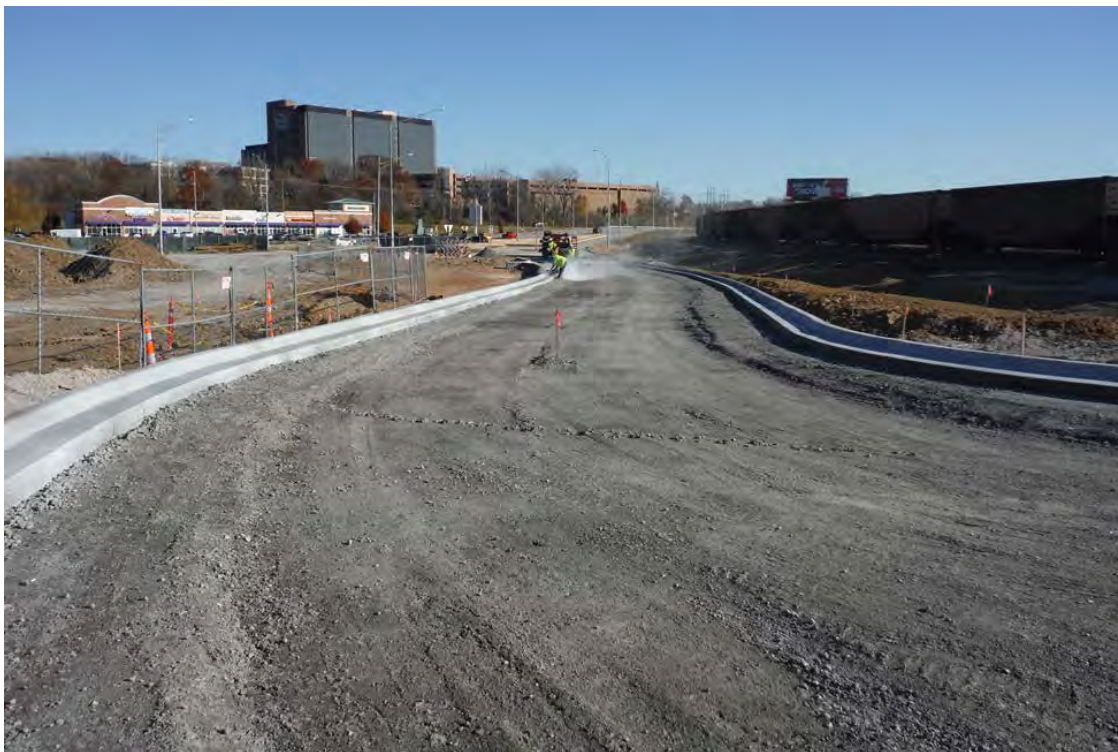
New Railroad Avenue curbs and base placed

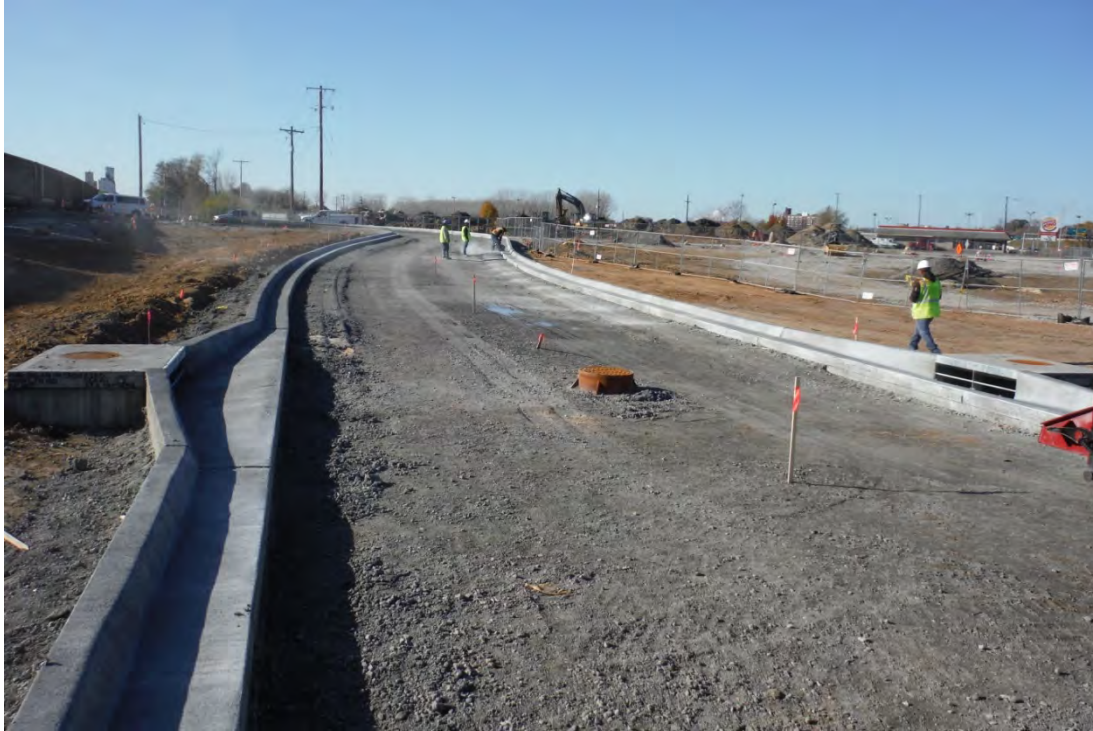
New Railroad Avenue storm water drop inlets

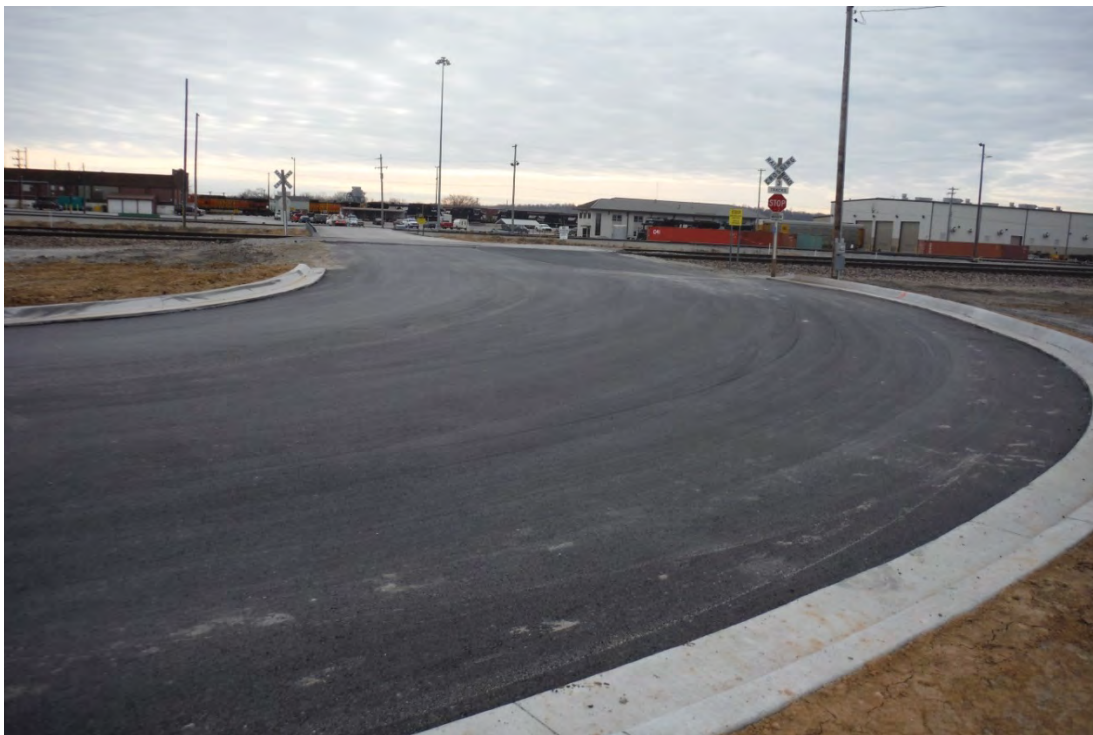
New Railroad Avenue paved near track crossing

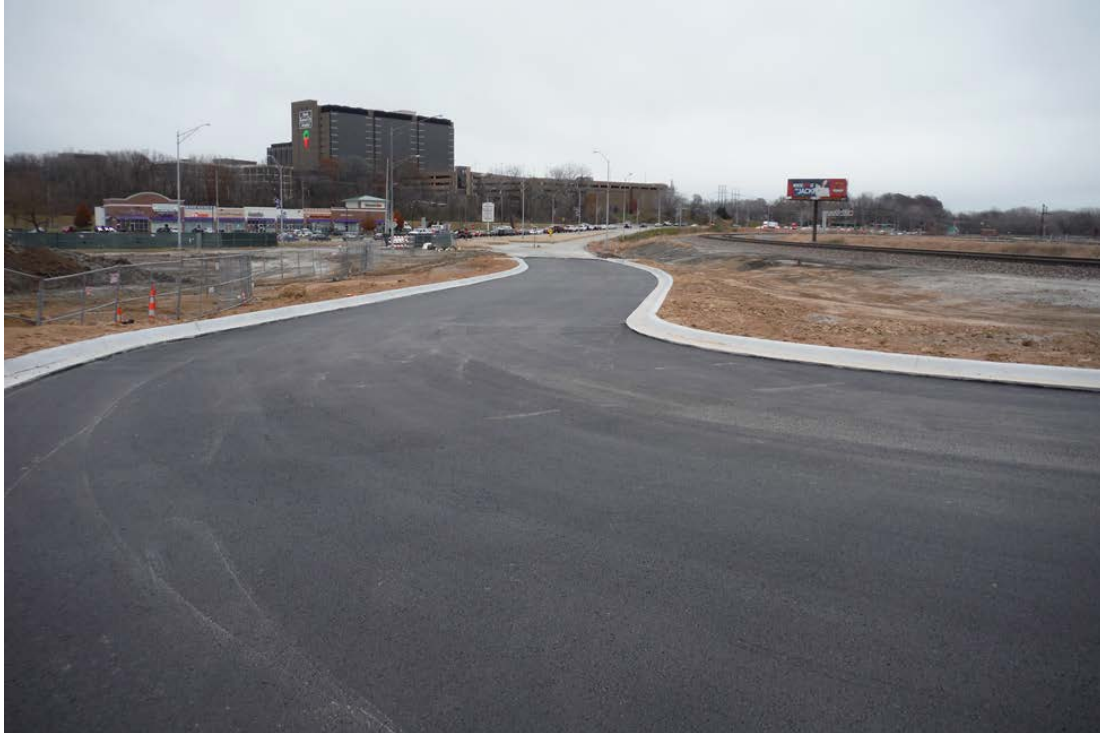
New Railroad Avenue paved looking east

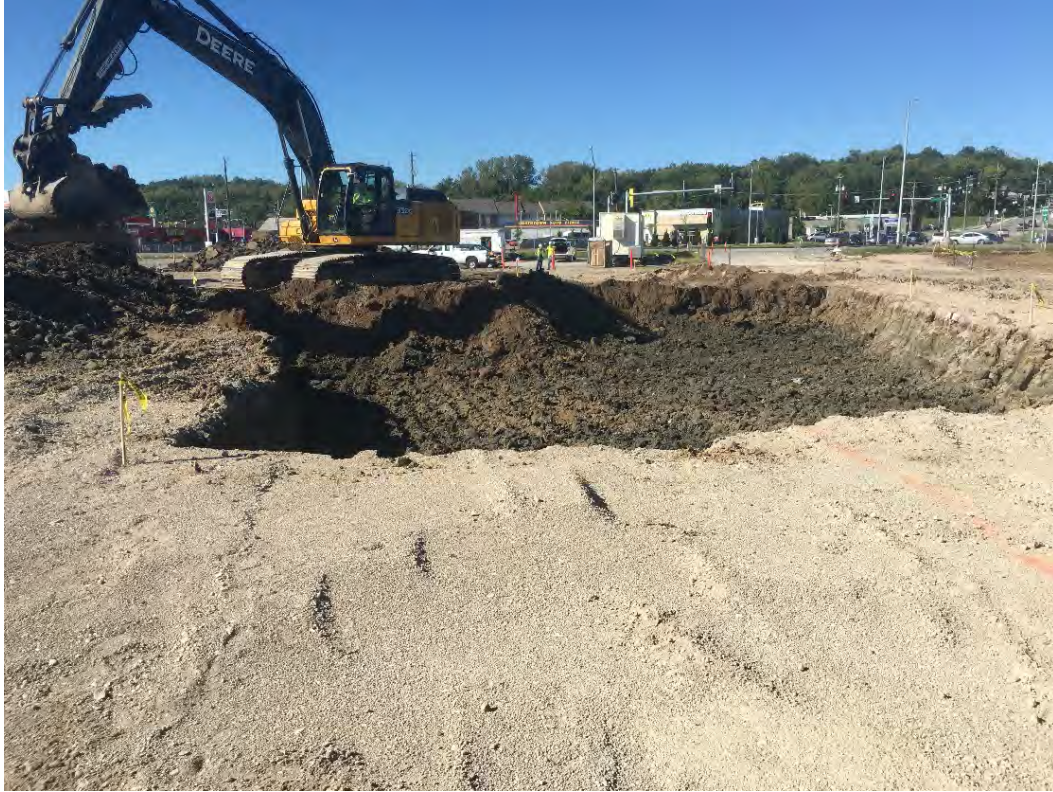
Initial excavation
